**BOEING AIRPLANE COMPANY**  
**WICHITA 1, KANSAS**

DOCUMENT NO. D3-2780 DATE 1-13-60  
MODEL All CONTRACT NO. \_\_\_\_\_  
TITLE SUMMARY OF TESTING: BMS 10-39 FUEL AND MOISTURE  
RESISTANT FINISH FOR FUEL TANKS  
ISSUE NO. \_\_\_\_\_ TO \_\_\_\_\_ DATE \_\_\_\_\_  
SHORT TITLE \_\_\_\_\_  
(FOR CLASSIFIED DATA)

**D3-2398, LABORATORY INVESTIGATIONS OF  
CORROSION PROTECTION IN B-52G INTEGRAL  
FUEL TANKS**

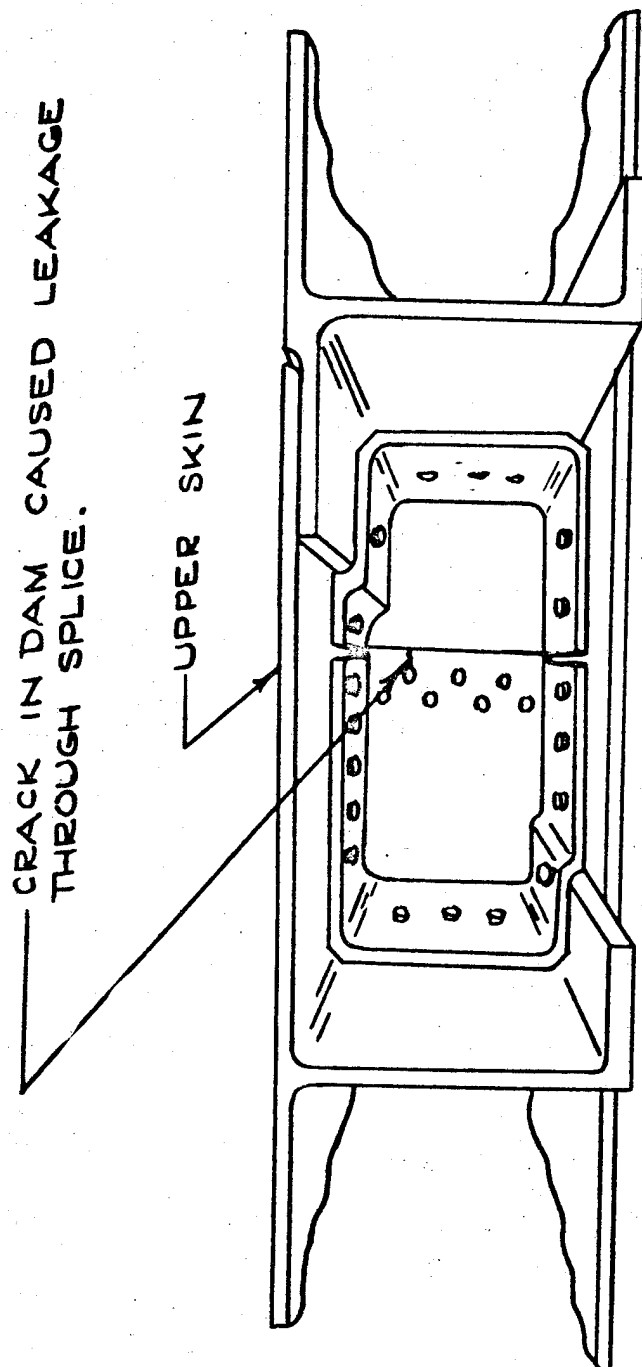
ILLUSTRATION NO. 3  
CRACK IN FUEL DAM

LEAKAGE OCCURRED AT FLUSH SEAL  
RIVET. THE LEAK TRAVELED TO THE  
SPLICE IN DAM WHERE IT WAS LOCATED  
OUTSIDE THE CUBE.

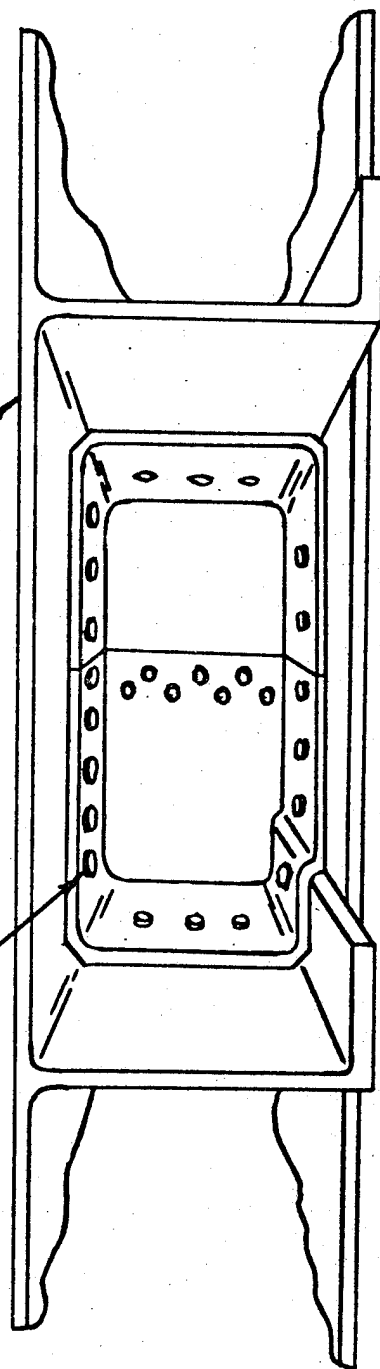
ILLUSTRATION NO. 4  
NACA RIVET LEAK

CUBE NO.	NO. OF LEAKS	LOCATION OF LEAK ON OUTSIDE STRUCTURE	LEAK DETECTION METHOD	INSIDE SOURCE OF LEAK	ACTION TAKEN
1	4	R. H. side, lower R. H. corner between lower rib chord and rib web	Ammonia - Leak Detection Paint Ammonia - Phenolphthalein Halogen Detector	Huck bolt not sealed	All huck bolts were sealed
2	1	R. H. side, between top of "Z" stiffener and lower rib chord	Ammonia - Phenolphthalein Halogen Detector Dyed Fuel	Tack rivet on top lower (see illust. No. 1)	Tack rivet sealed
	1	L. H. side, between top of "Z" stiffener and lower rib chord	Ammonia - Phenolphthalein Halogen Detector Dyed Fuel	AN bolt leaked (see illust No.2)	AN bolt resealed (bolt out of direct line of vision and difficult to seal) Fillet applied over crack in dam
	1	L. H. side, between bottom of upper center fuel dam and rib chord	Halogen Detector	Small crack in fuel dam (see illust. No. 3)	
	1	L. H. side, between bottom of upper fuel dam and rib chord (second dam from RF)	Halogen Detector	NACA rivet in upper fuel dam leaked (see illust No. 4)	Rivet was sealed
